# A Full House Inspection Co. LLC

## CONFIDENTIAL INSPECTION REPORT

123 Main Street, Anytown, NJ 07777

7/8/2008 2:00 pm to 5:00 pm

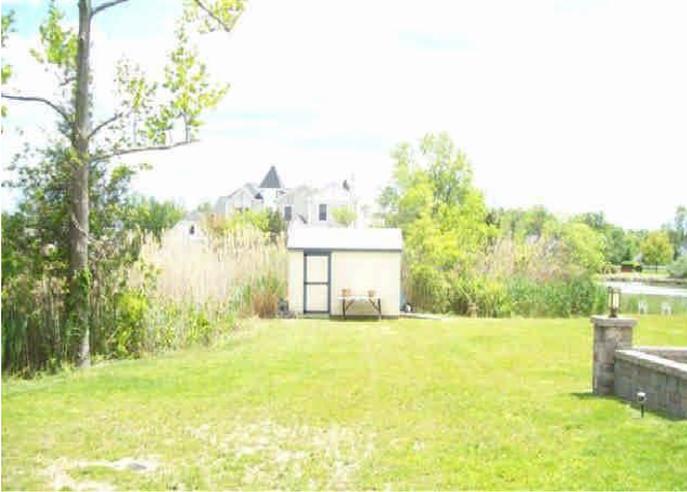
Comment on Ancillary Buildings - *Continued*

- Our inspection service does not include auxiliary buildings, structures, trellis, gazebos, tool sheds, BBQ, storage barns or related system(s)/component(s), including encroachments. We will gladly answer questions you may have about these items which are specifically excluded from our report. Our answers are not to be construed as a "verbal" not written report, and therefore you should not rely on them. Our position is that if you have questions means you are concerned, and you should seek professional advice. You should obtain the necessary permits because we do not tacitly endorse any structure that was installed or built with or without permits, and latent defects could exist.

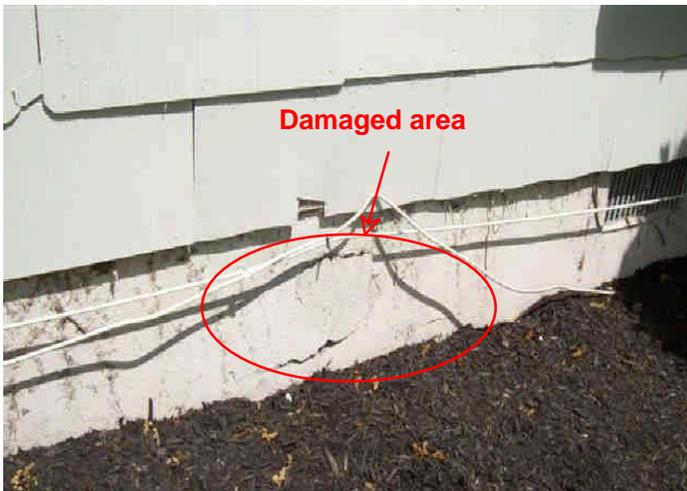
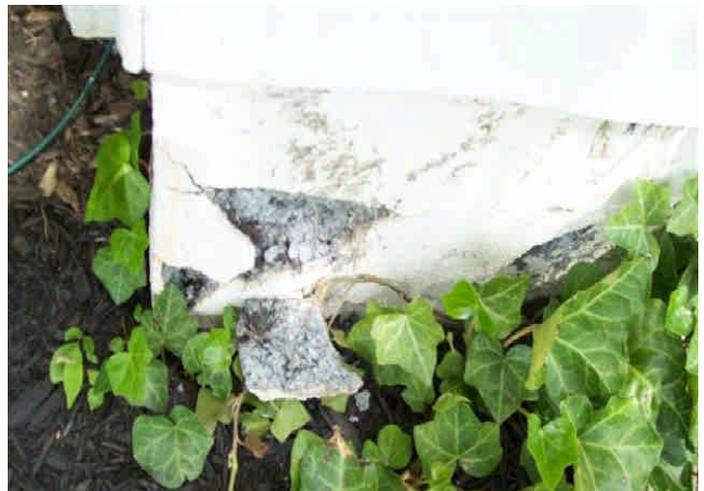
- Q The parge coating on the exterior foundation walls at the right side is damaged and should be repaired. Retain a qualified contractor for evaluation. (As an upgrade, installing a wire lath to help add strength and reliability to the coating is recommended)

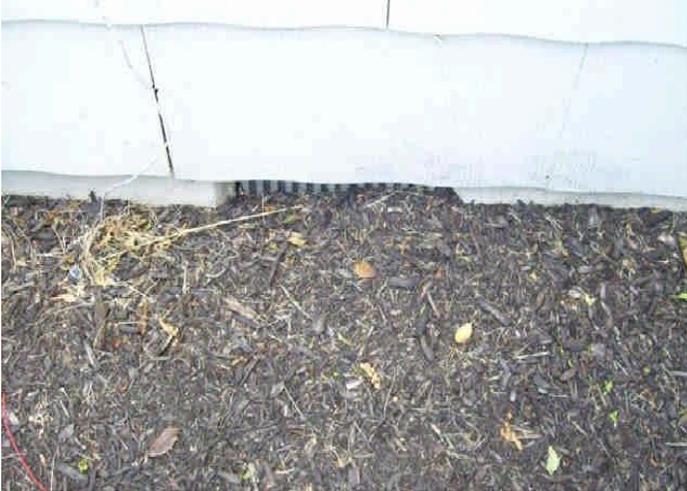
- √ Several of the crawlspace vents are at soil grade level has allowed moisture and related conditions (deterioration/rot and WDI infestation, etc.). As an upgrade, installation of the "well or wells" is recommended. Consult with an qualified contractor for details and estimates.

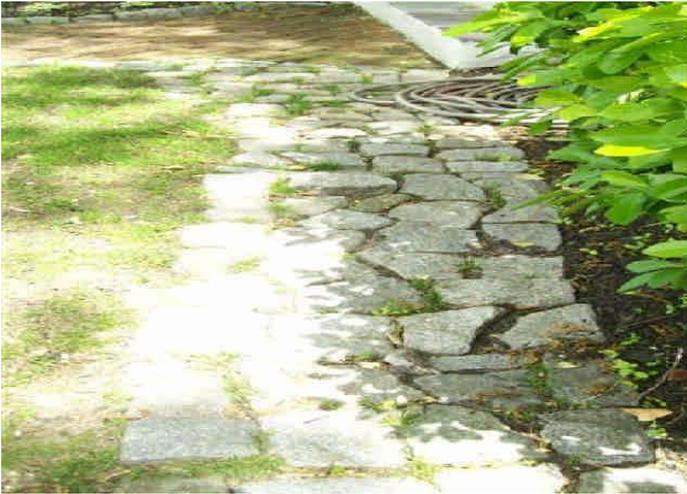
Replace walkways - *Continued*

- m The cobblestone section of the front walkway has offsets and should be repaired as trip hazards are present.

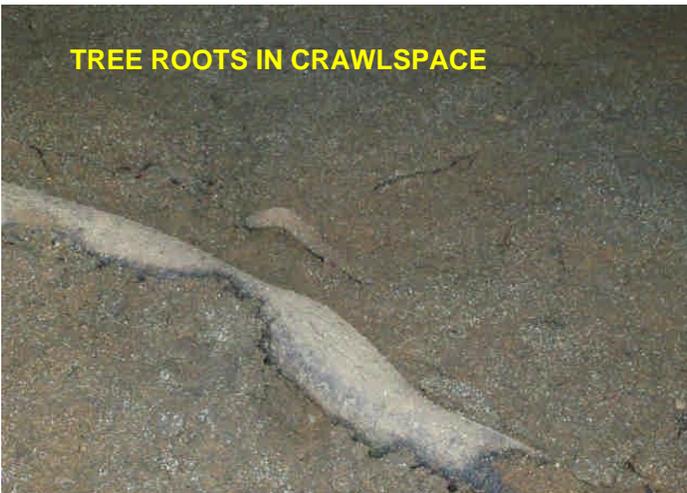
- Our inspection does not include the evaluation of trees, bushes, and other vegetation but may include comments as these plants may affect the structure or safety of the occupants and visitors.
- q One or more tree(s) adjacent to the structure should be monitored for any growth, above or below grade, that might affect occupants and the dwelling (structure, roof, walls, etc).

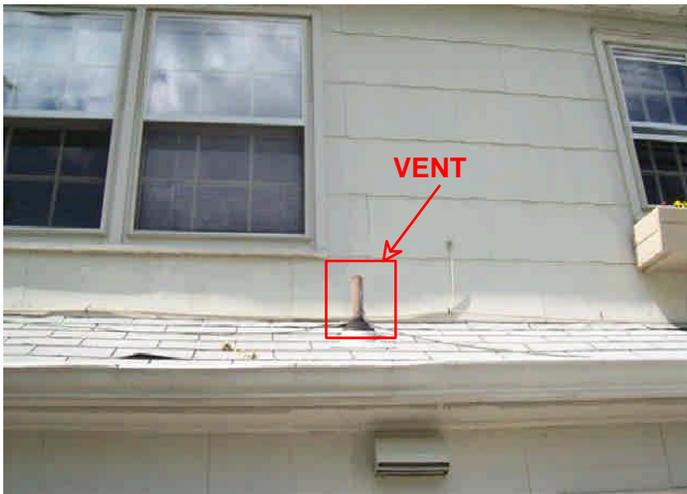
- m A plumbing vent at the rear over the kitchen is too close to the bedroom window, and does not properly extend above the roof line. A licensed plumber evaluate this condition and make all necessary repairs.

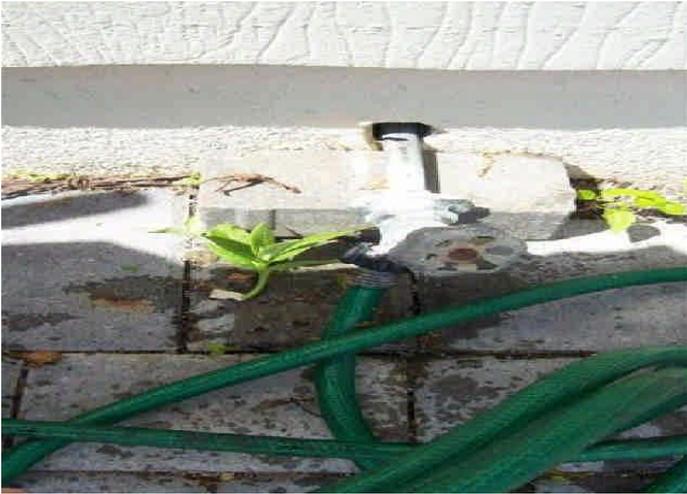
Secure Loose Hose Bib - *Continued*

- q The leaking hose bib/faucet at the patio is loose and should be repaired, and secured to the dwelling. (Loose bibs can be easily damaged, and allow moisture entry)

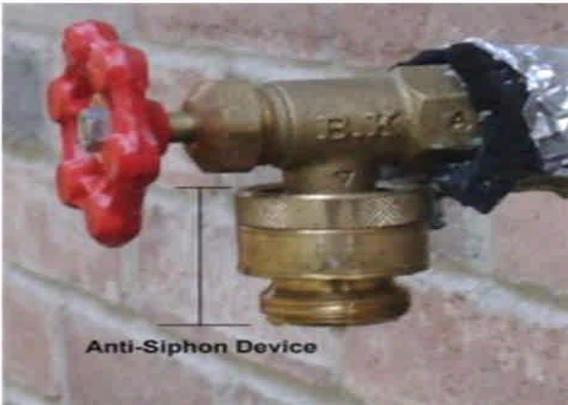
- m One of more of the hose bibs have not been fitted with anti-siphon (backflow) valves which help prevent contaminated hose water from entering the potable water supply system. These valves are relatively inexpensive and are required by current standards.

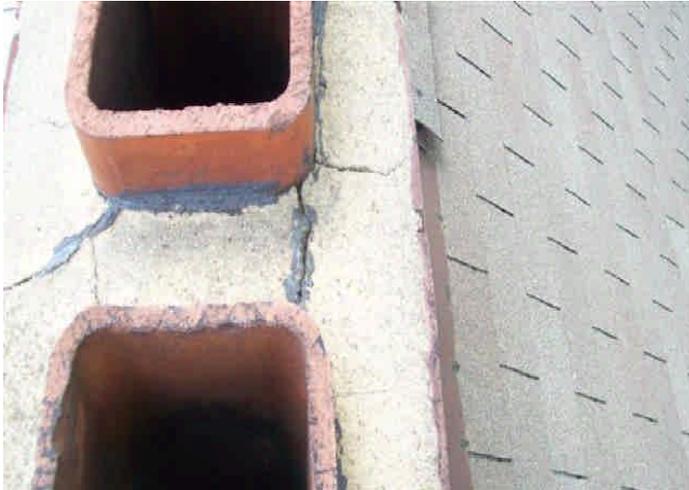
- q The cracked chimney mortar cap which is designed to seal the chimney wall and shed rainwater, should be sealed.

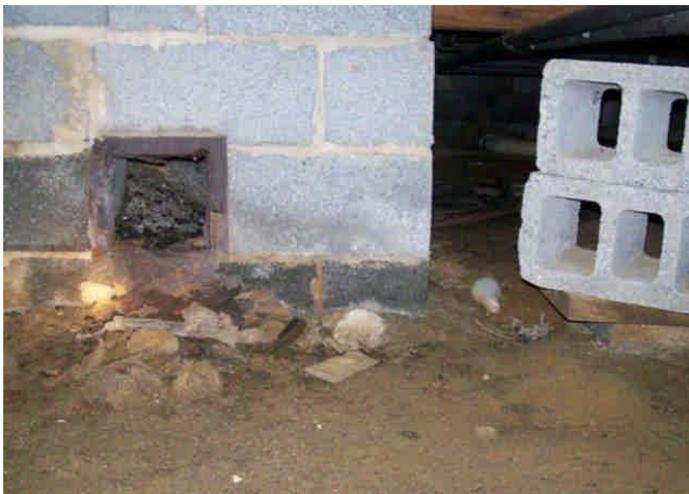
- m The ash box is full and needs to be cleaned. The door on the ash box is missing, and should be installed to contain embers.

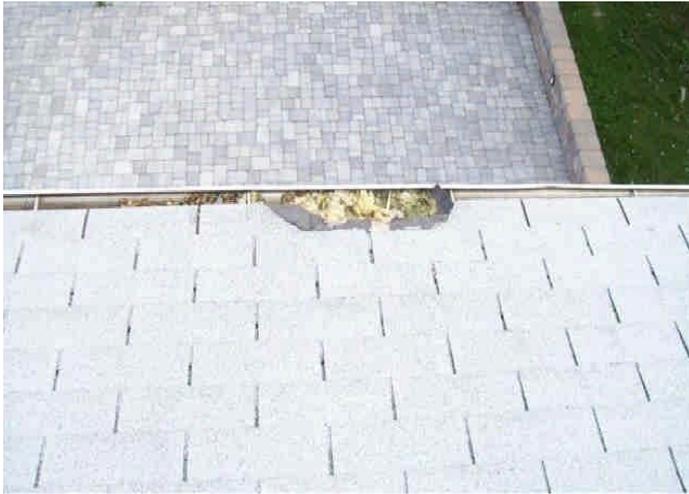
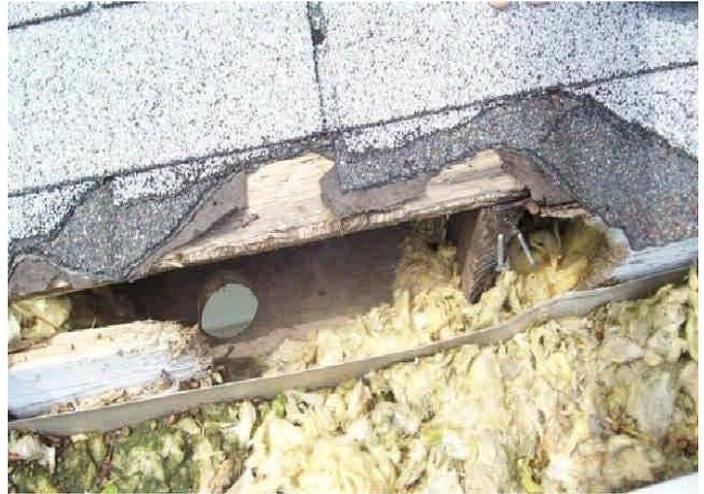
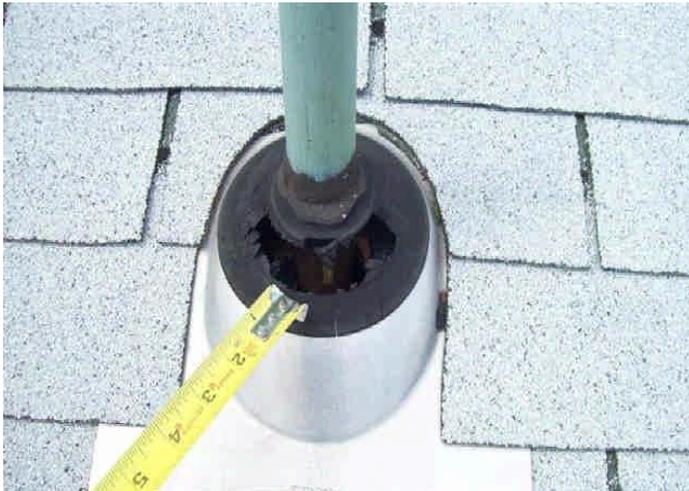
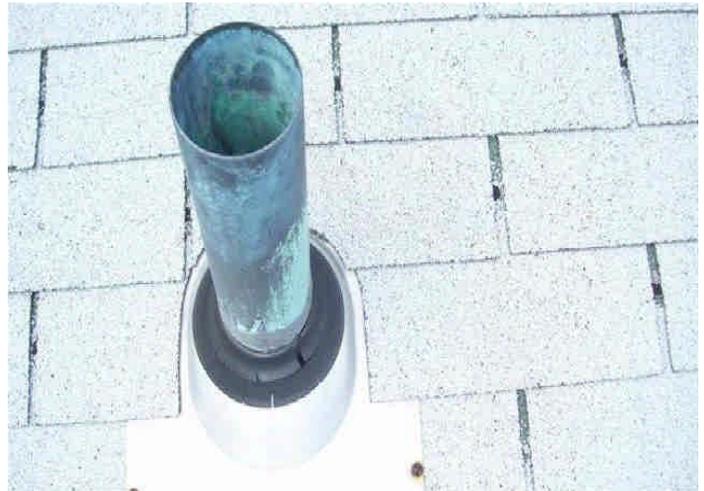
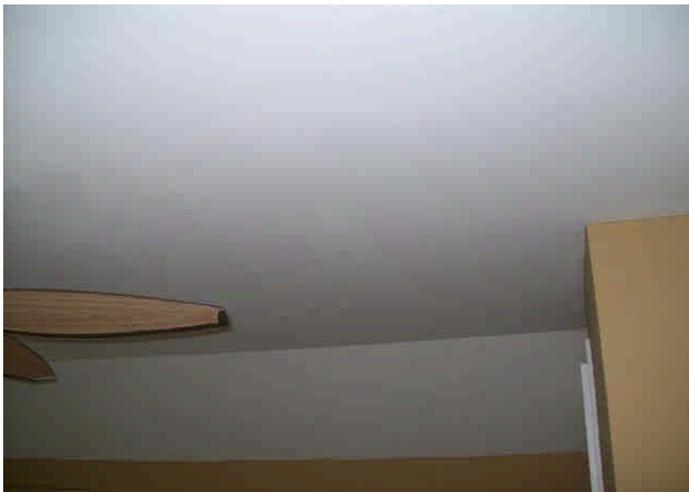
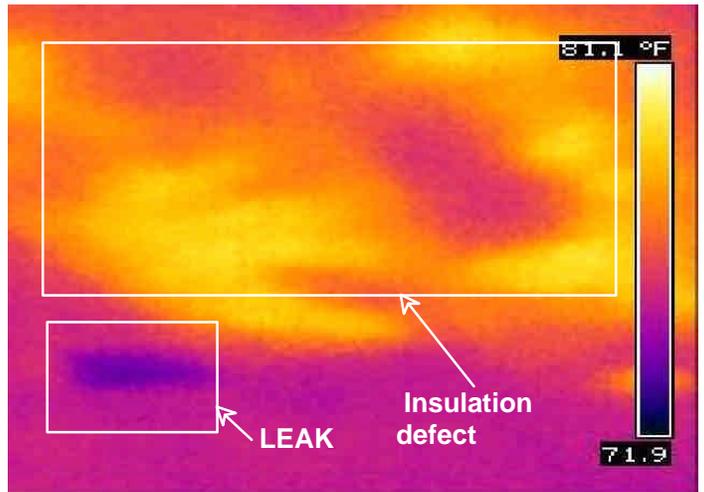
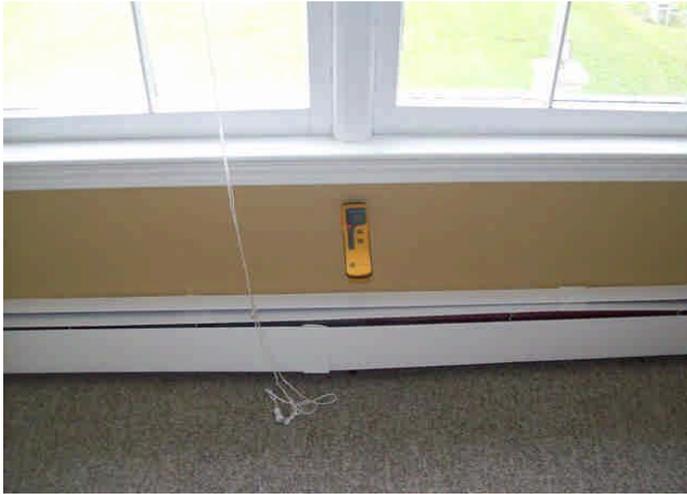
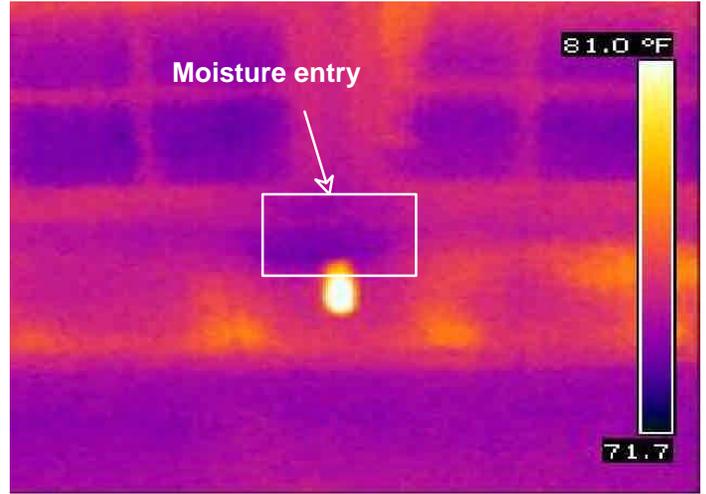
Replaced damaged shingles - *Continued*

- √ Several courses of roof shingles are damaged at rear field area. The flashings for the plumbing vents are deteriorated, and should be replaced. The thermal images detected amorphous patterns from moisture entry in the second floor right side bedroom ceiling and rear wall under the windows. A qualified contractor should determine the source of all leaks, which should be eliminated, and replace all damaged shingles.

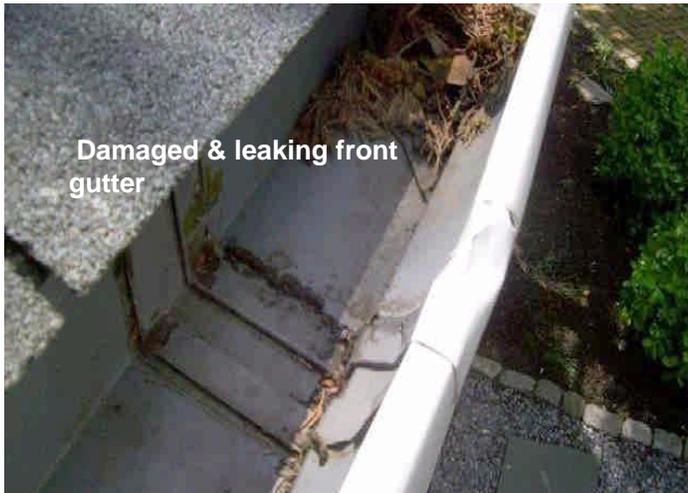
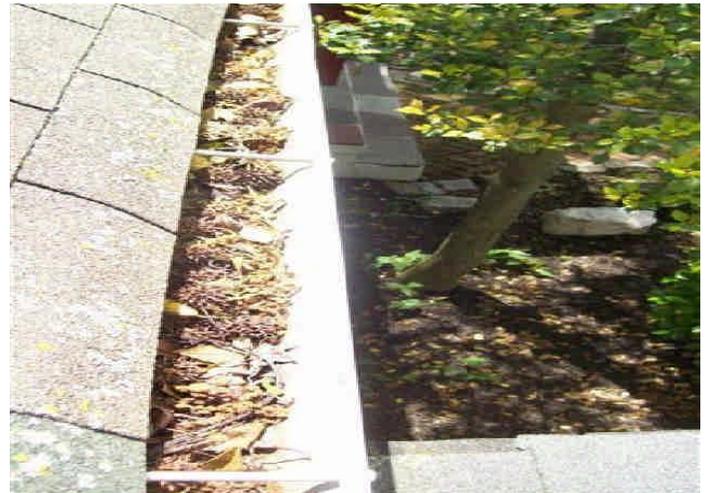
**Repair or replace Gutters - Continued**

- The gutters have several deficiencies: unsecured sections, leakage, disconnected components, debris accumulation. The gutters should be repaired, if possible, or replaced. The gutter system is an important component in the exterior water management which helps prevent moisture entry into the dwelling.

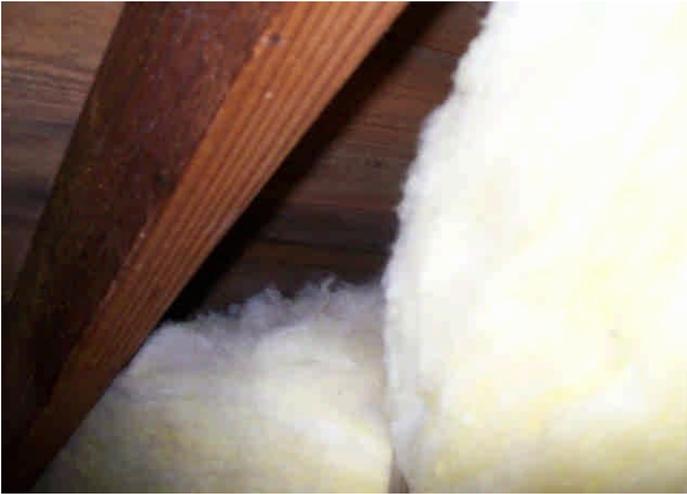
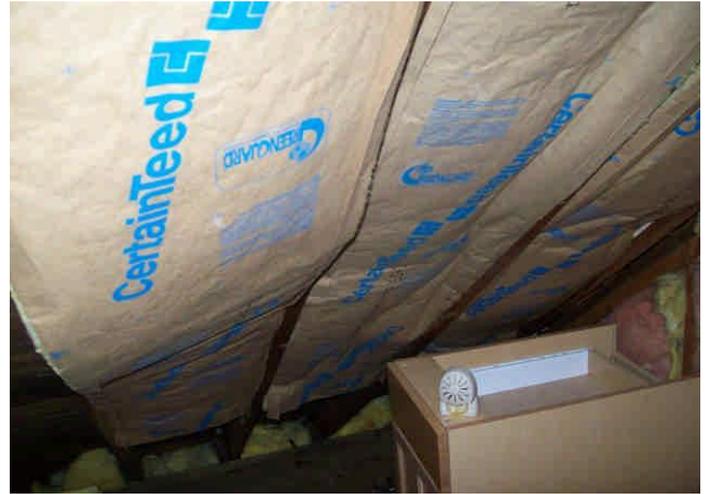
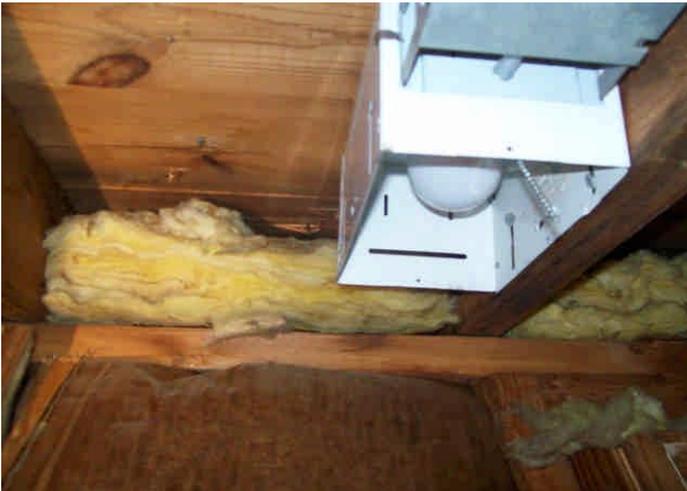
Correct Attic Insulation - *Continued*

- q The insulation has been installed between the rafters without air baffles/trays which can overheat the roof. This condition can decrease the life expectancy of the roof unless a proper air passage is established between the sheathing and insulation. Retain a qualified contractor to correct this condition.

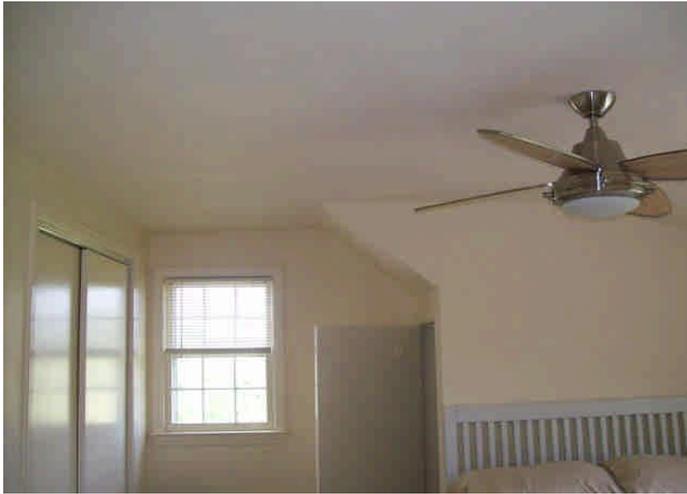
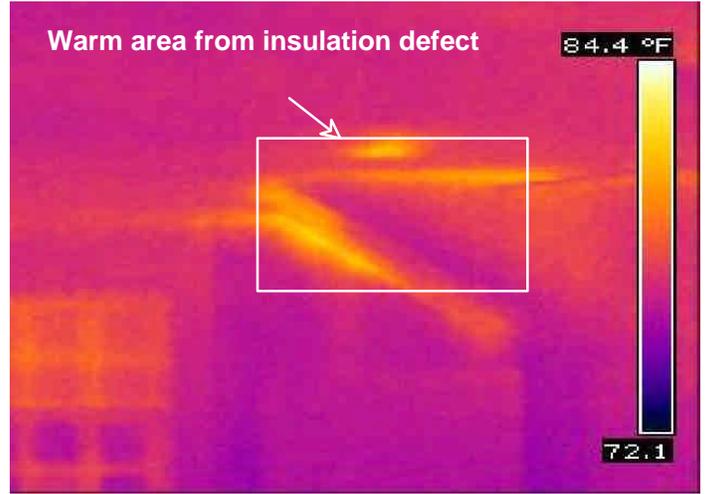
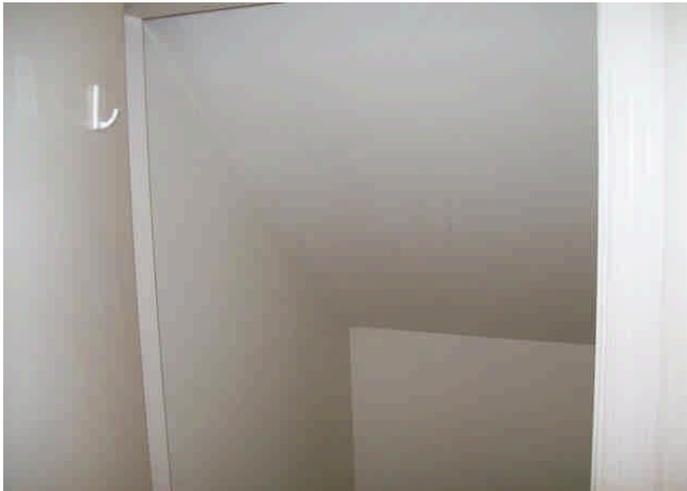
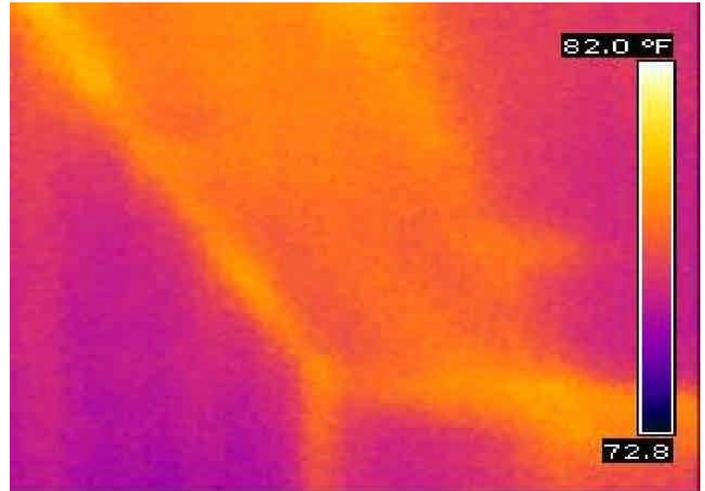
IR Scan Results - Continued

- ∨ The thermal images of the bedrooms revealed air infiltration ( illustrated in yellow/orange and white ) due to insulation which is missing/damaged with voids. Retain a qualified contractor for evaluation and correction.

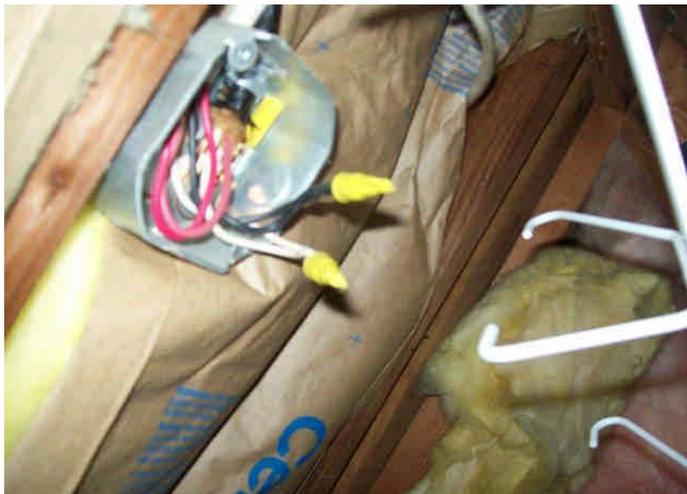
- m The open electrical junction box at the attic laundry area is missing a protective cover which should be installed. (Open junction boxes are a fire/safety hazard)

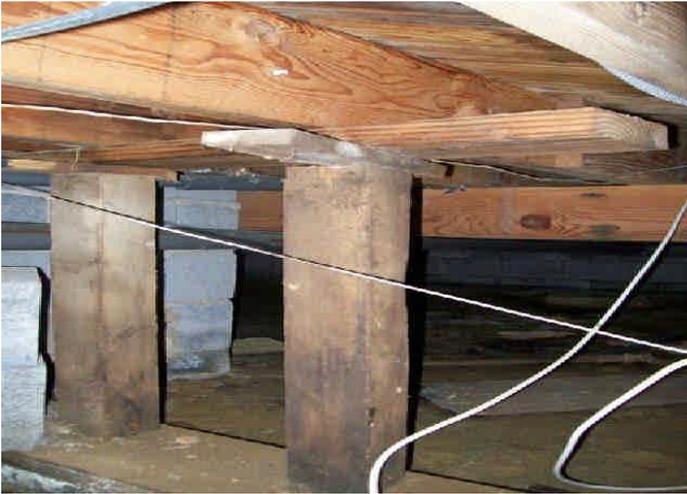
Wood posts are in contact with the soil - *Continued*

- ✓ We noted wood posts that are in contact with the soil under the kitchen which are conditions conducive to moisture and/or pest damage. Typically, this installation practice lacks satisfactory footings. While no visible damage or deterioration was noted, we recommend modifications to the installation to break the earth-to-wood contact. These modifications are likely to include installation or replacement of inadequate footings.

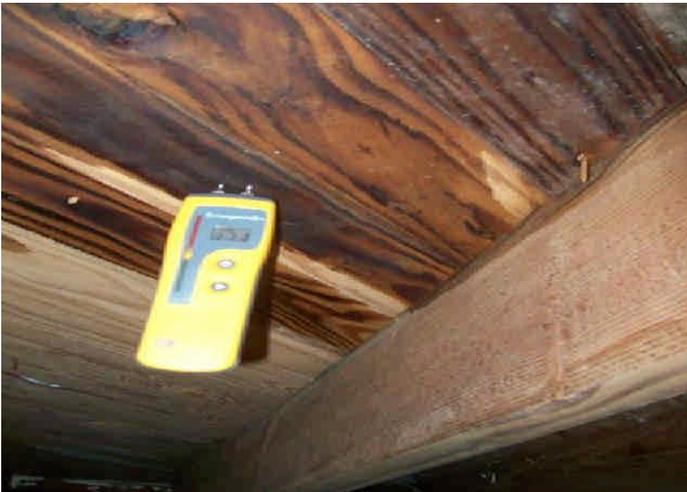
- ✓ Subflooring under the kitchen/laundry areas are wet. The source of the moisture should be positively identified and eliminated.

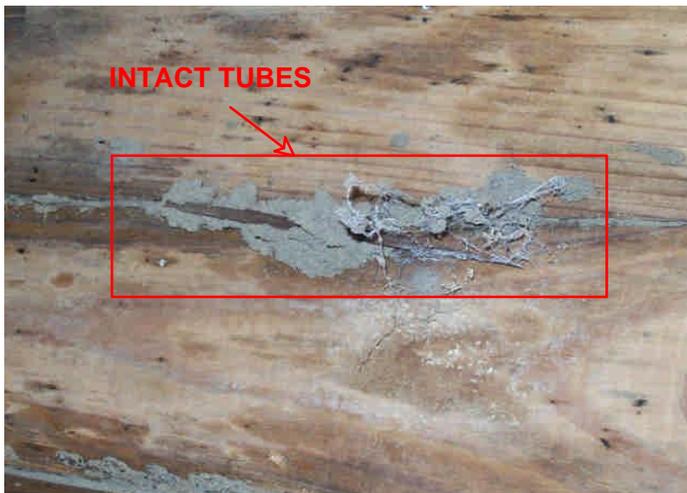
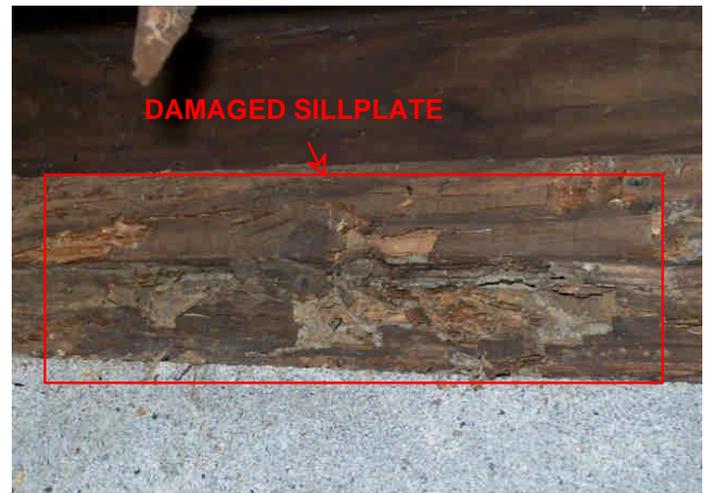
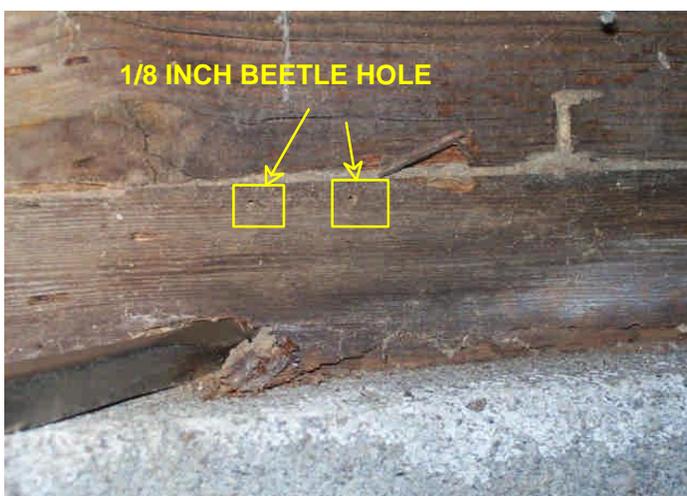
- ✓ We noted active wood destroying insect (WDI) infestation in the subfloor at the right rear corner of the crawlspace ( intact termite shelter tubes and wood boring beetle) A licensed pest control operator is necessary for evaluation and treatment services, and a contractor for repairs. Review our detailed separate "Wood Destroying Insect Infestation Inspection Report" form NPMA-33. Note: our inspections do not include any type of warranty nor treatment. It should be understood that some degree of unknown and hidden damage may exist inside the inaccessible finished surfaces and framing. In many cases, based upon visible signs of infestation by WDI it is possible without benefit of subsequent invasive inspections and evaluations over a period of time to ascertain whether an infestation is active or inactive.

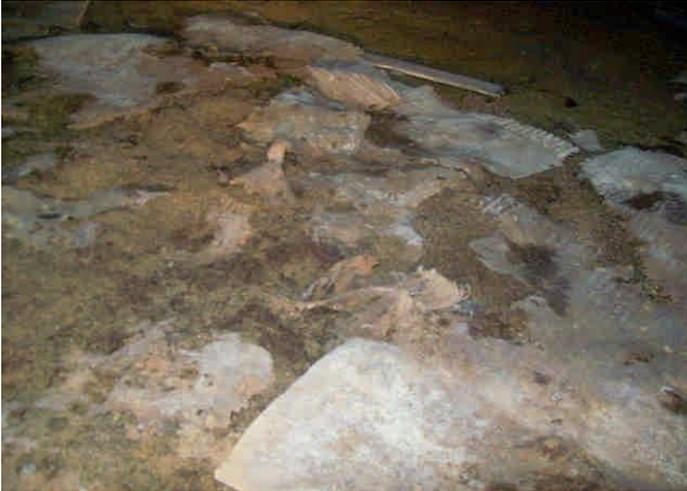
- q Debris/scraps, and other cellulose materials are in contact with soil, and should be removed to reduce the potential for mold, mildew, fungus and WDI/WDO infestation, and related damage.

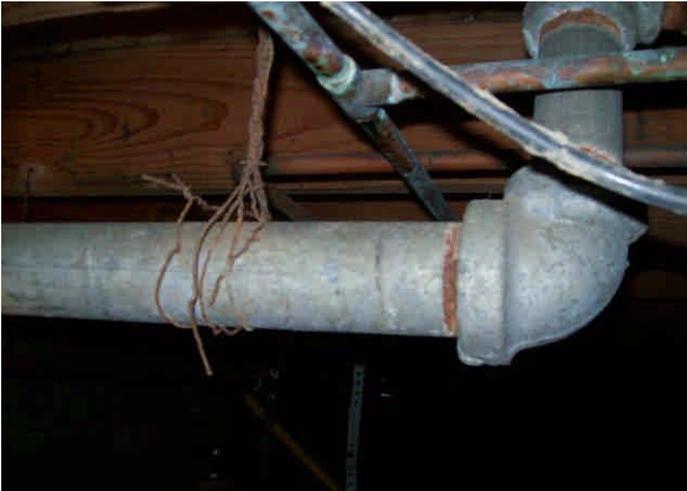
Piping minimally supported add - *Continued*

- q Several sections of the galvanized wastelines are minimally supported with damaged wire which should be corrected by a licensed plumber. ( Incorrectly supported wastelines are susceptible to leaks. )

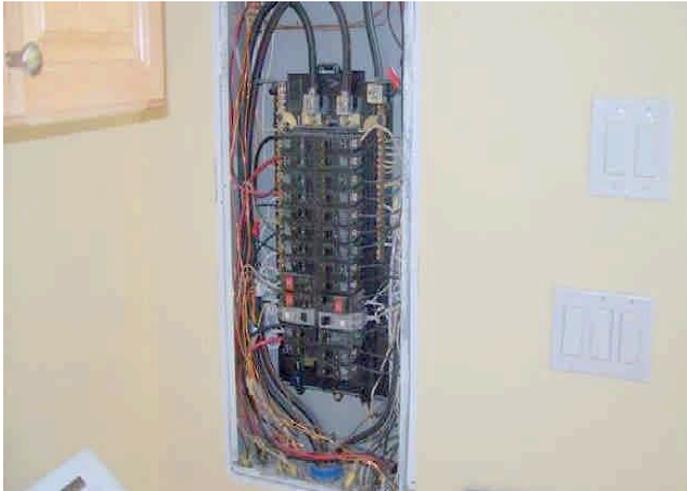
There are no visible deficiencies with the circuit breakers in the main electrical panel - *Continued*

- There are no visible deficiencies with the circuit breakers in the main electrical panel.

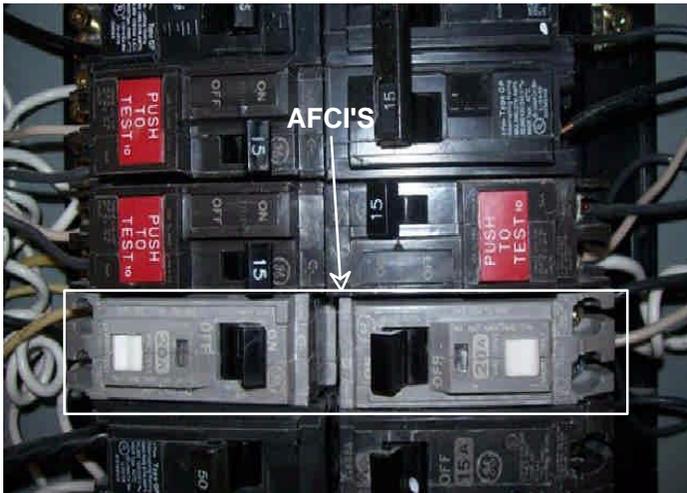
Upgrade to arc-fault circuit interrupters - *Continued*

- Arc fault circuit interrupters (AFCI's) are safety devices designed to help prevent fires caused by electrical arcing and sparking. Since January 2002, they have been available for use in residential bedroom circuits. Older buildings, built before these requirements took effect, may not have this protection. You may want to consider adding AFCI protection for both new and existing buildings. Older buildings with ordinary circuit breakers especially may benefit from the added protection against the arcing faults that can occur in aging wiring systems. The arc fault breakers present were tested by tripping off the built-in tester, and the results are satisfactory.

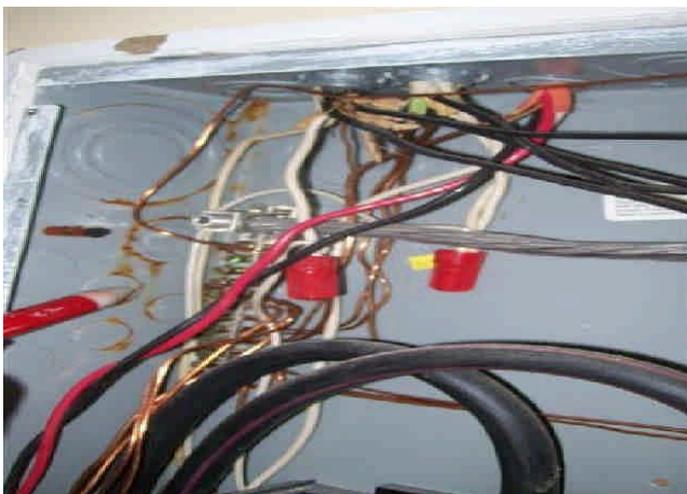
- m There is staining and corrosion at the upper left hand corner from moisture entry. A licensed electrician should determine the source of moisture which should be eliminated.

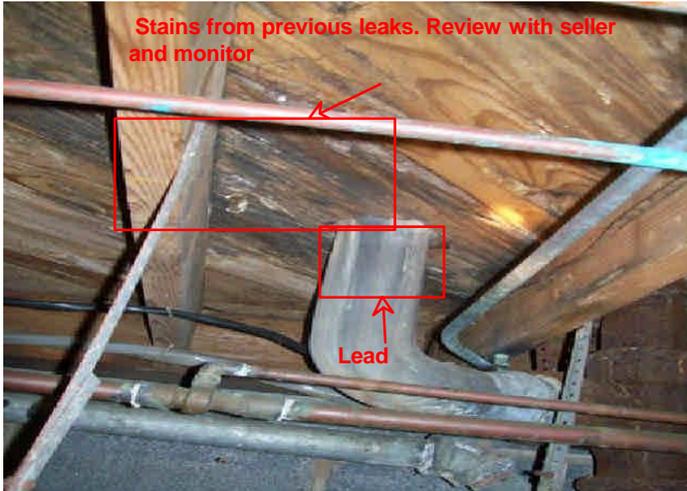
We observed lead components in the drain system i e \_\_\_ - *Continued*

- There are lead components in the waste plumbing system at the toilet sleeves. Lead for the waste piping were used in homes typically built in the 1950's. Lead piping is prone to leakage at the connections, and should be closely monitored.

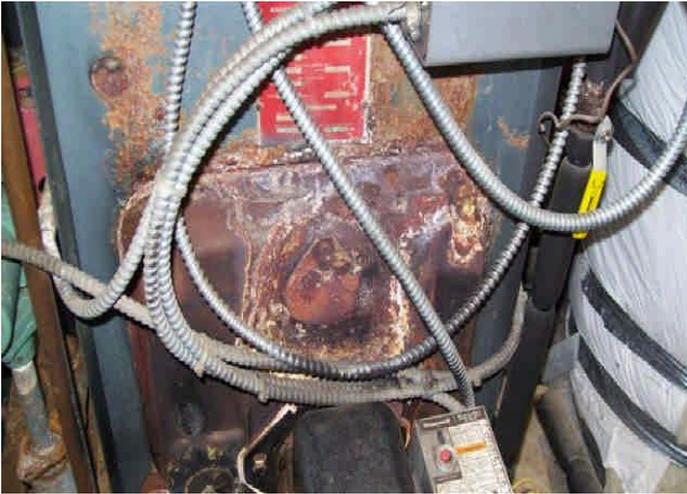
The boiler is old and has multiple deficiencies - repair or REPLACE - *Continued*

- √ The boiler has significant accumulation of rust from previous leaks, and is approaching the end of its designed life and needs to be serviced for the following reasons below. This service should be scheduled within the inspection period, because a specialist might reveal additional defects or recommended upgrades that could affect your evaluation of the system which should be certified as safe to operate or repaired as necessary or replaced.

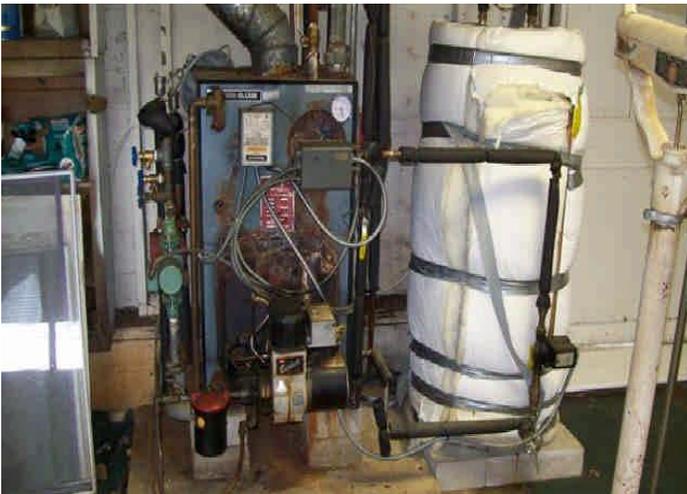
- m The boiler is located in the garage and is exposed to vehicle impact and damage. Installation of a proper barrier is necessary.

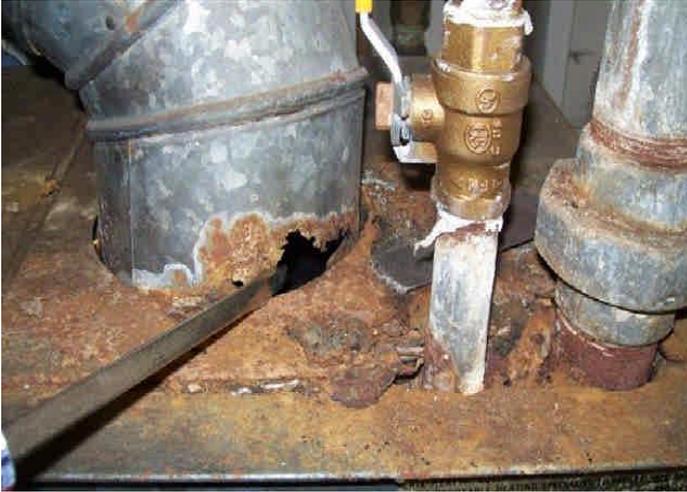
**Corroded Flue Vent Connector - Continued**

- m The flue vent is deteriorated which will allow carbon monoxide to accumulate in the garage. A qualified HVAC contractor should replace the flue as soon as possible. The barometric damper did not respond during the boiler operation and should be serviced.

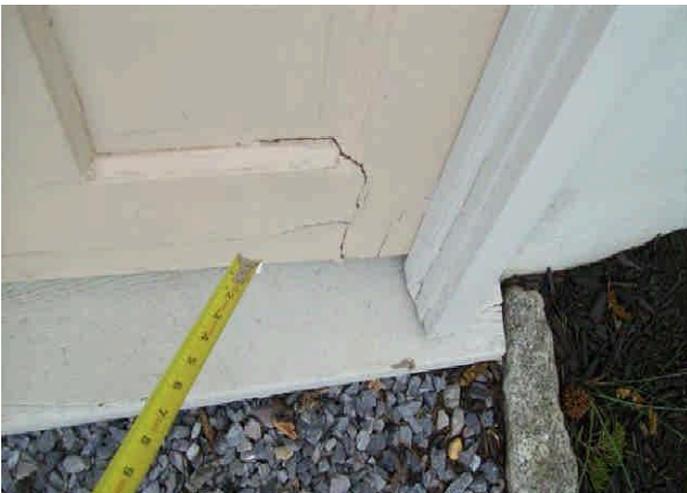
- q The base of the garage side door is moisture damaged and should be repaired or replaced.

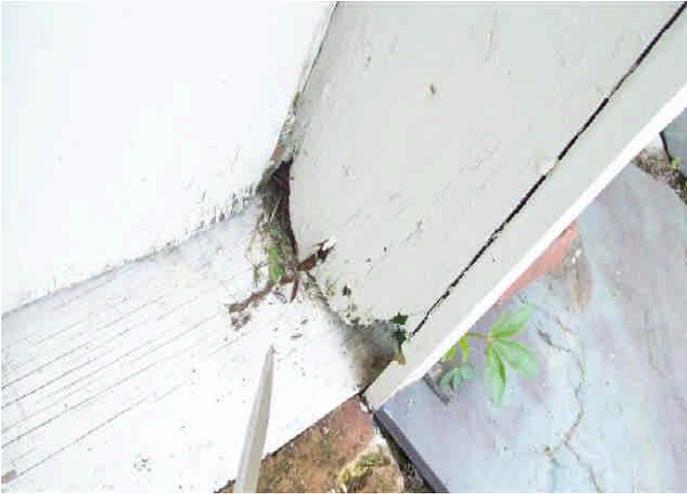
- q The deteriorated side door jamb should be replaced.

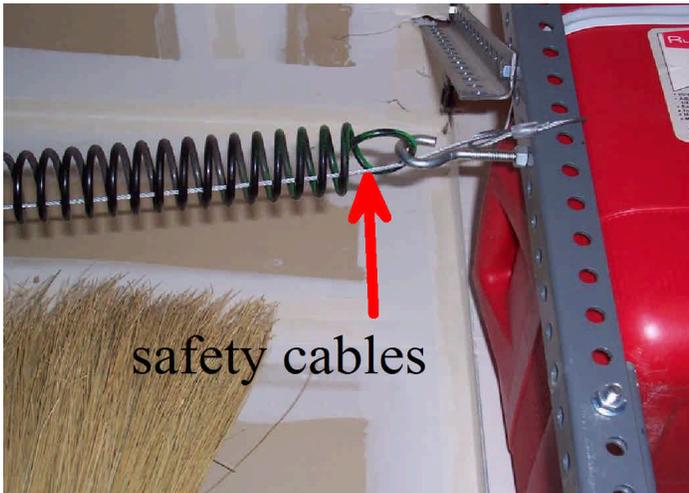
The garage door springs lack safety restraint cables - important safety issue - install - *Continued*

- m The garage door(s) counterbalance springs lack safety restraint cables designed to prevent injury to persons nearby and/or damage to property located in the garage area, in the event of spring(s) breaking. Because of the great force of impact from breaking springs this is a very important safety concern. For improved safety have safety restraint cables properly installed as soon as possible.

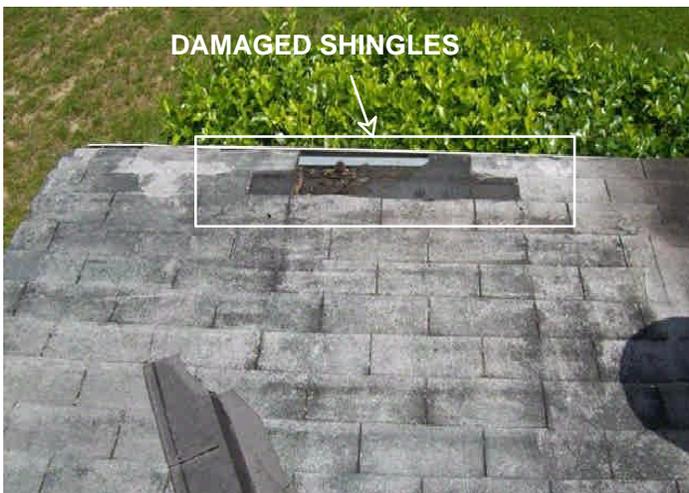
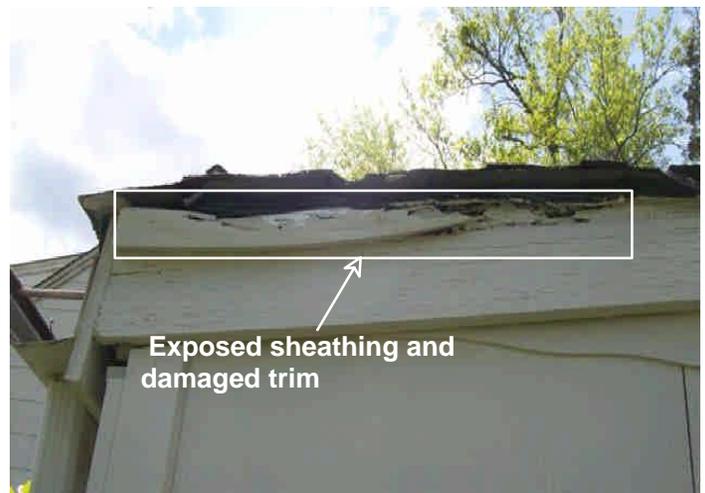
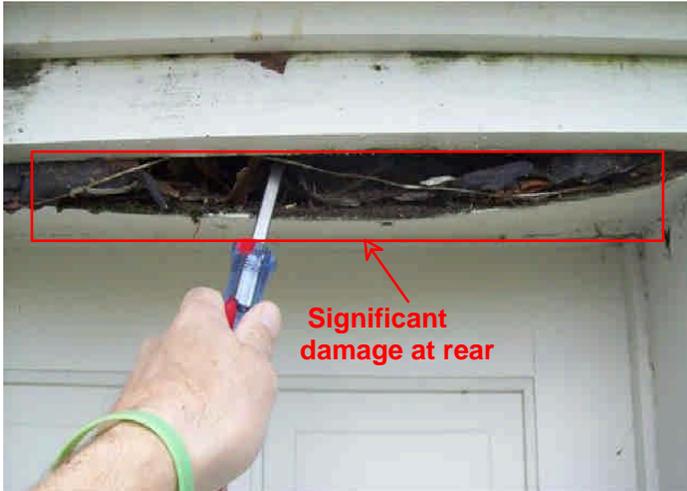
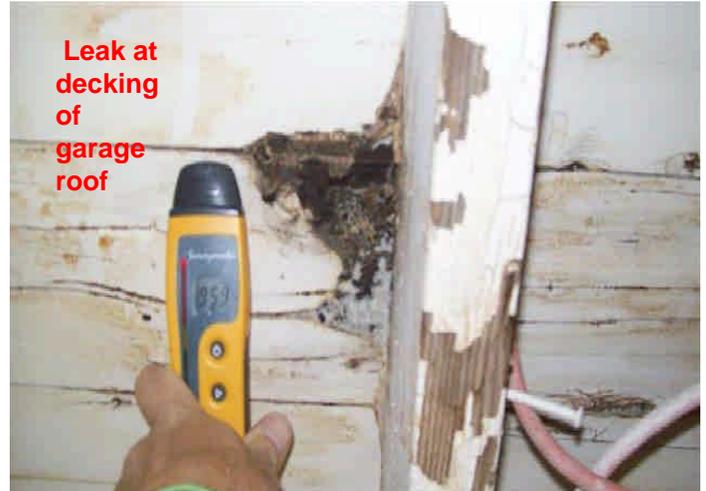
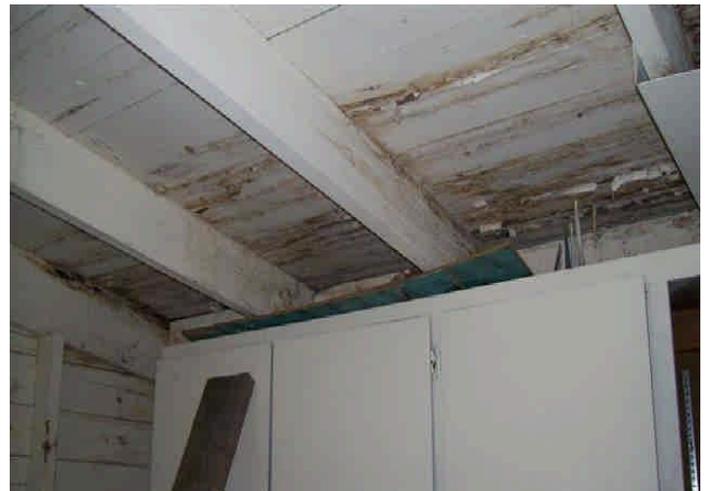
Replace Roof - Continued

- v The garage roof is leaking at several locations with significant damage to the decking/sheathing. The roof surfaced areas, related flashings and decking should be evaluated, and replaced as necessary by an established and qualified roofing contractor.

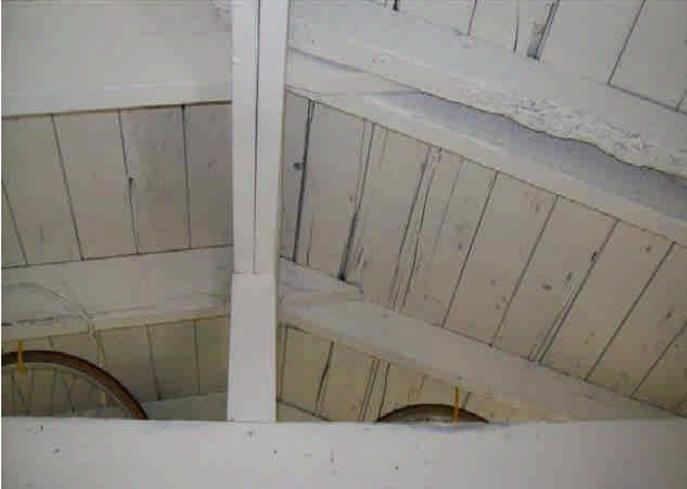
*Reinforce Framing at - Continued*

- ∨ The roof rafters are minimally supported by a rotated ridge board. Further evaluation and additional support are recommended.

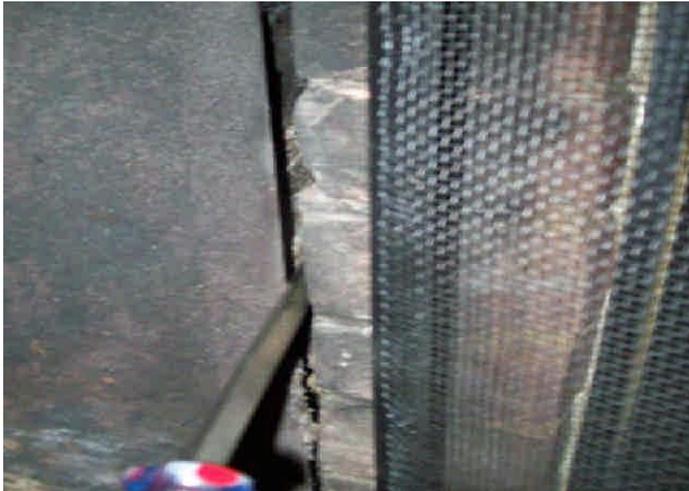
### Gaps at Surround - *Continued*

- m The fireplace chimney flue has accumulated soot and creosote and should be cleaned by a professional and certified that the fireplace and chimney are safe to operate.
- m There are gaps between the metal firebox and brick surround, which should be sealed, as fire hazard exists.

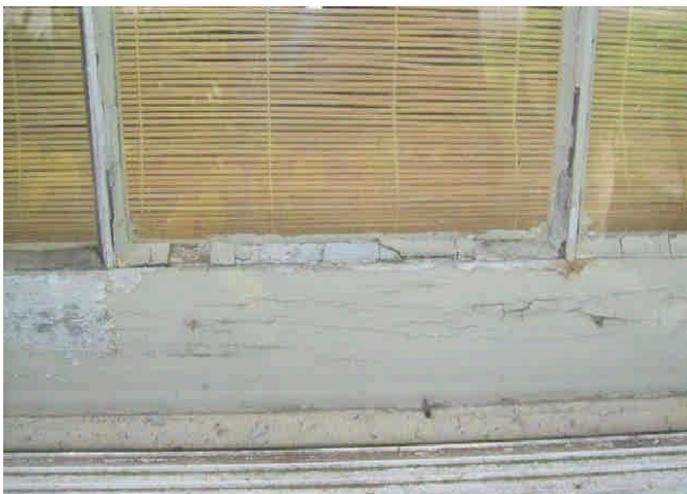
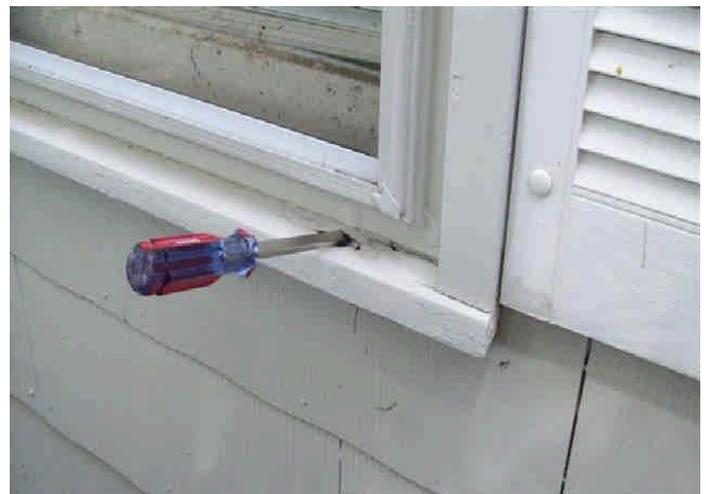
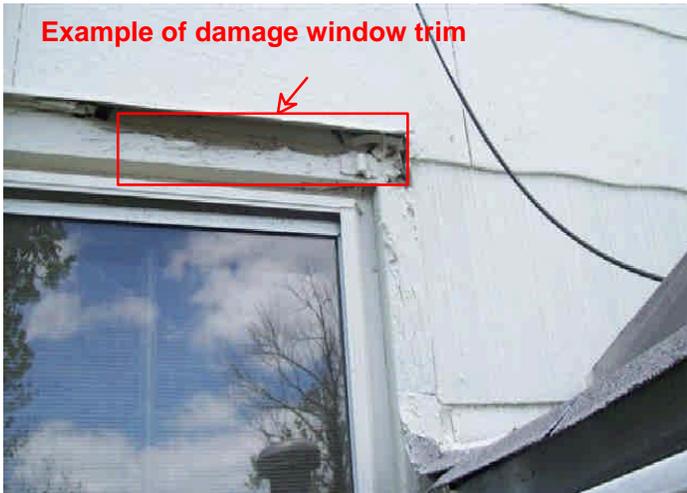
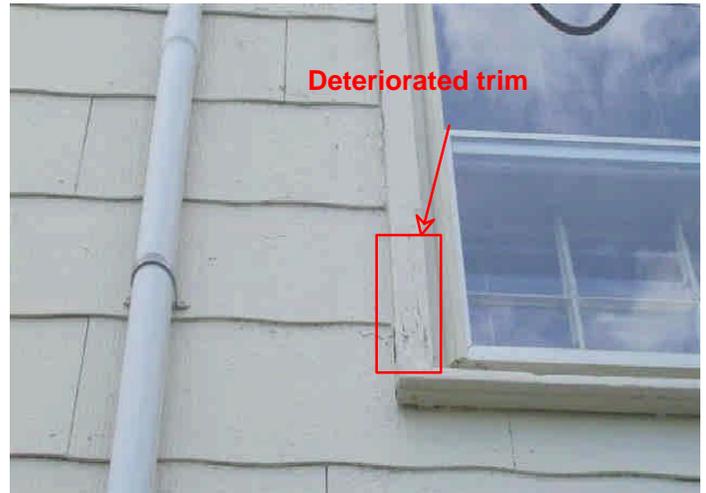
Repair Replace Wood Windows - *Continued*

- √ The wood windows are in overall poor condition (damaged sills, glazing and putty, missing/broken window locks, inoperable ). While repairs are necessary, a cost effective solution may be a complete window replacement and recommend a second opinion from an established contractor who should inventory all windows for estimates and advice.

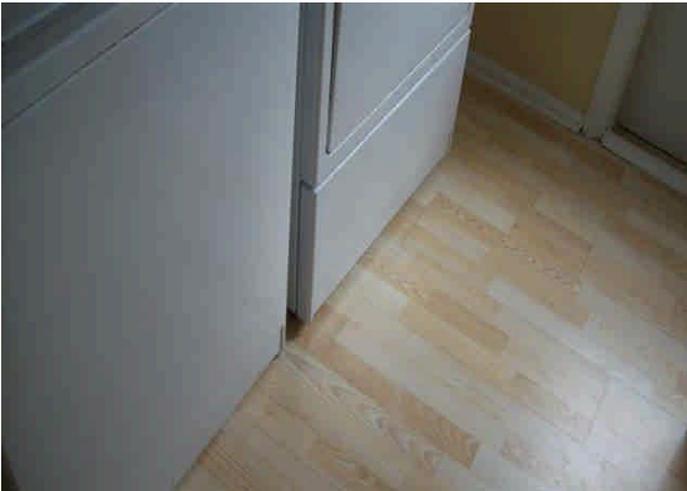
- q There is no drain and pan for the washing machine which should be installed, as an upgrade.
