# A Full House Inspection Co. LLC

## CONFIDENTIAL INSPECTION REPORT

123 Main Street, Anytown, NJ 07777

7/8/2008 2:00 pm to 5:00 pm

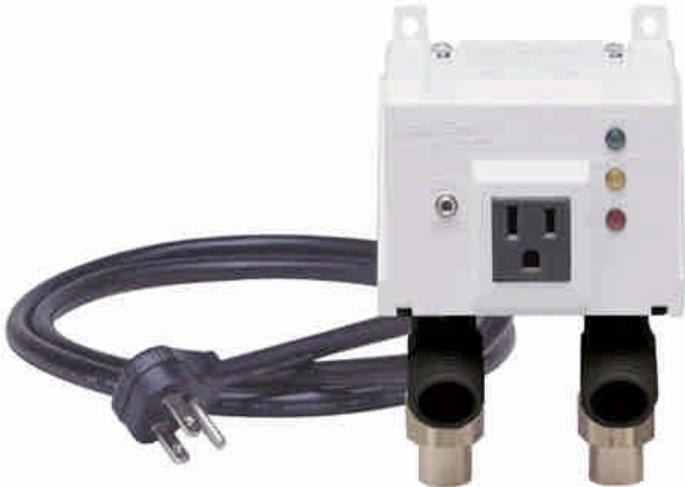
- q We recommend upgrading the water supply hoses to the burst resistant type typically consisting of stainless steel braided to help prevent damage from leakage.
- The Watts IntelliFlow Automatic No. 2 (A2C-M) is equipped with a state of the art electric current sensing device. When the washer is turned on, the device senses the current flow to the washer. When the shut-off valves are left on, the constant water pressure can cause hose fatigue. This can increase the potential for leakage or a burst hose. Upon completion of the full wash cycle when the washer shuts off, the device will sense the lack of current and close the water valves. Such automatic operation protects against a water

damage repair situation should a washing machine inlet hose burst while the machine is unattended. More information can be obtained at <http://www.watts.com/pdf/f-intelliflow.pdf> ( We have provided this information as a courtesy, and have no affiliation with this company. )

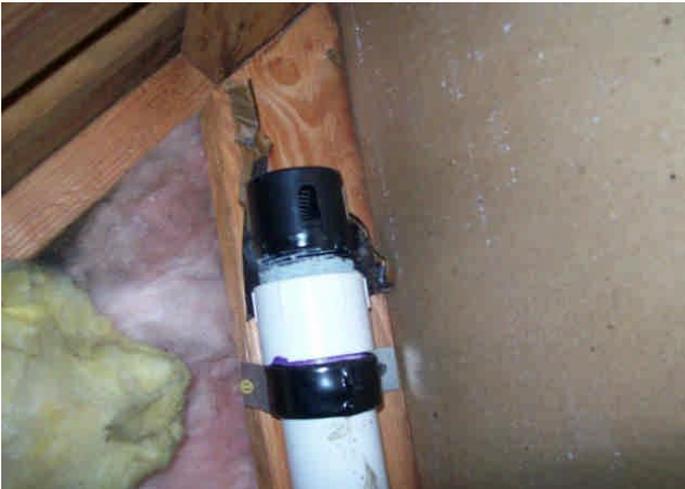
- m The wasteline plumbing for the second floor laundry area consists of an air admittance valve which is not permitted in most jurisdictions. Retain a licensed plumber to correct this condition.

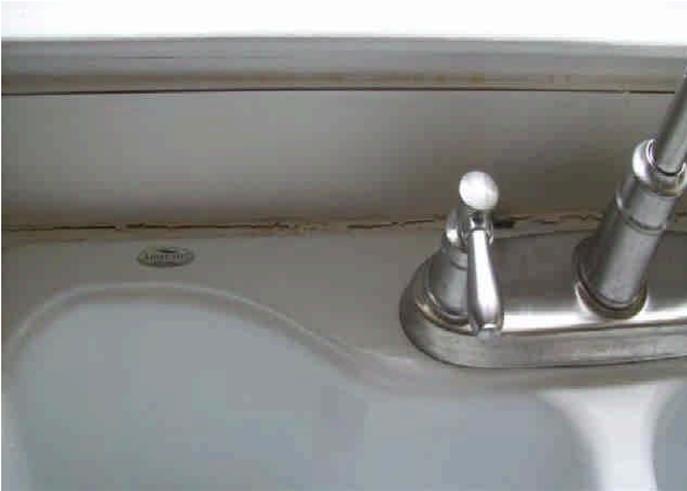
- The kitchen counter top is in satisfactory condition.
- Q There is no caulking between the kitchen counter top and the backsplash which should be installed to prevent moisture intrusion.

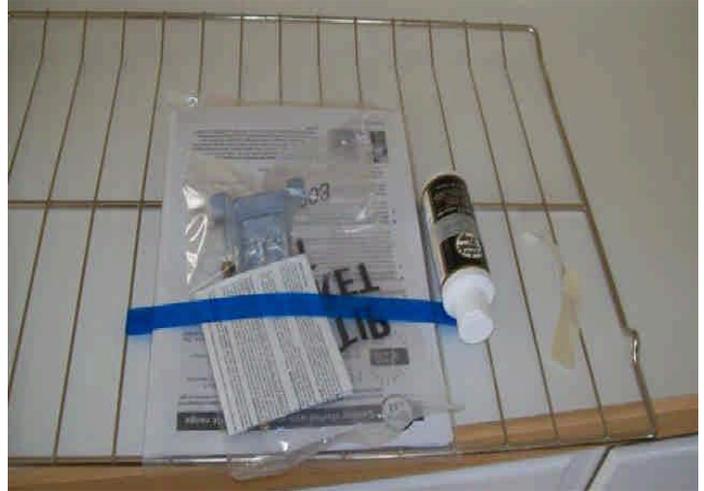
- m The range does have an anti-tip bracket which is required per the manufacturer's label and should be installed to help prevent accidental tipping, damages and related injury.

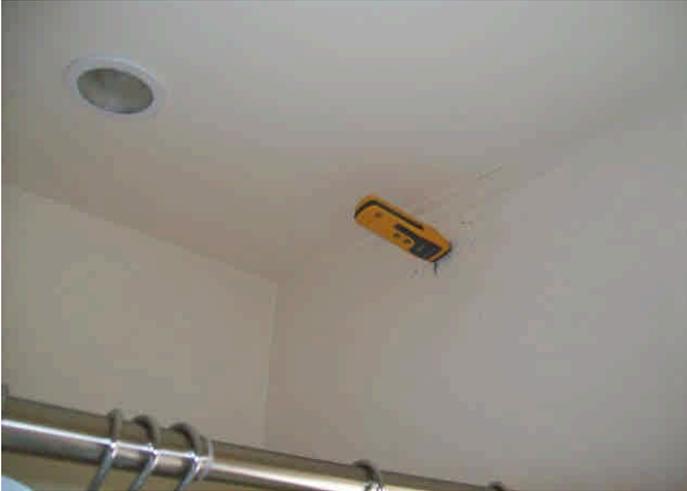
- v There is a leak at rear wall area at the top of the shower. A qualified contractor should determine the source of the moisture entry which should be corrected.

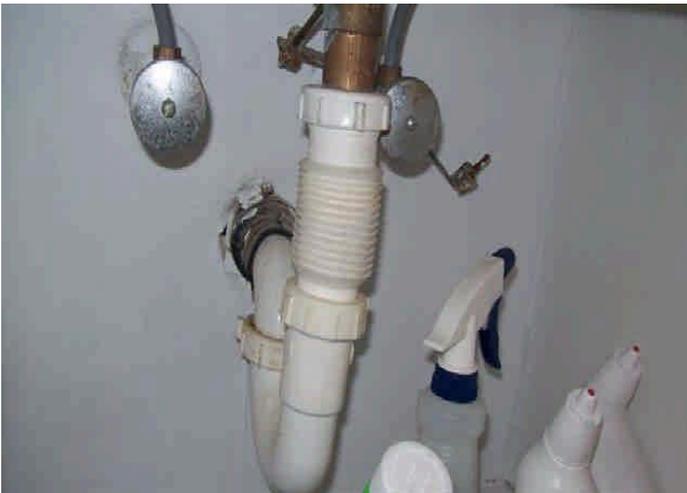
- o The sink drain system includes non-conforming flexible material and recommend the installation be replaced with approved materials for reliability.

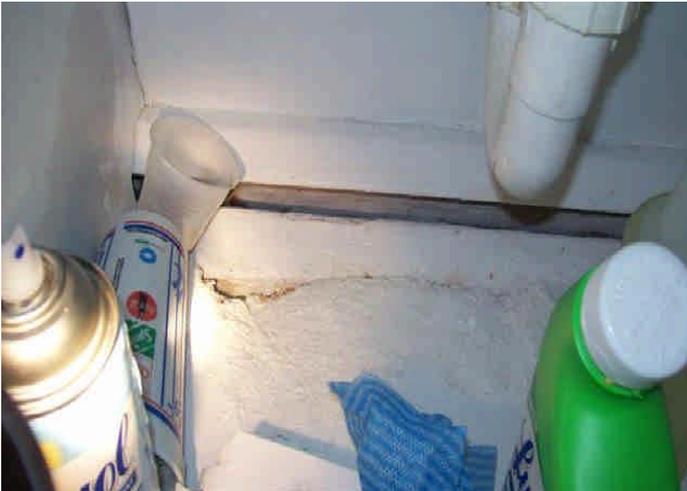
- q The floor of the sink cabinet is damaged, and should be replaced.

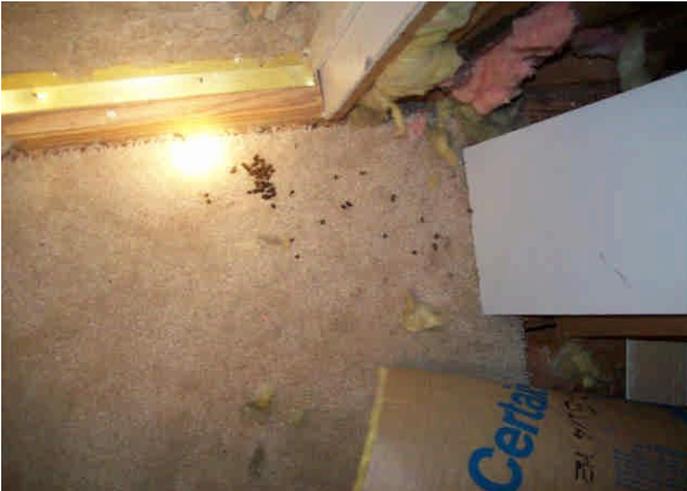
- m There is evidence of pest activity ( rodent droppings in attic ) and recommend consulting with an integrated pest management company.

There is evidence of rodent activity \_\_\_\_ -- get licensed pco - *Continued*

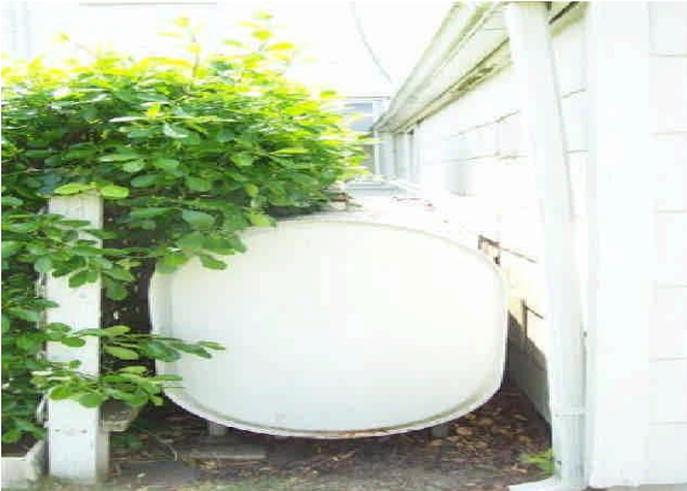
- m Our inspection of the above ground oil tank is a limited visual observation of the readily accessible areas/components for leakage only. No adverse conditions were noted. Leaking fuel oil can contaminate the soils and ground water and result in an environmental issues and very significant clean-up costs. Many oil service companies offer an insurance policy to service contract customers that may help eliminate or reduce homeowner liability in the event of leakage. We recommend such a policy and if already in effect, we recommend the policy be continued.

Oil tank - *Continued*
